A SURVEY OF THE WRECK OF
THE SS RICHARD MONTGOMERY

A SUMMARY REPORT

The Maritime and Coastguard Agency

June 1998

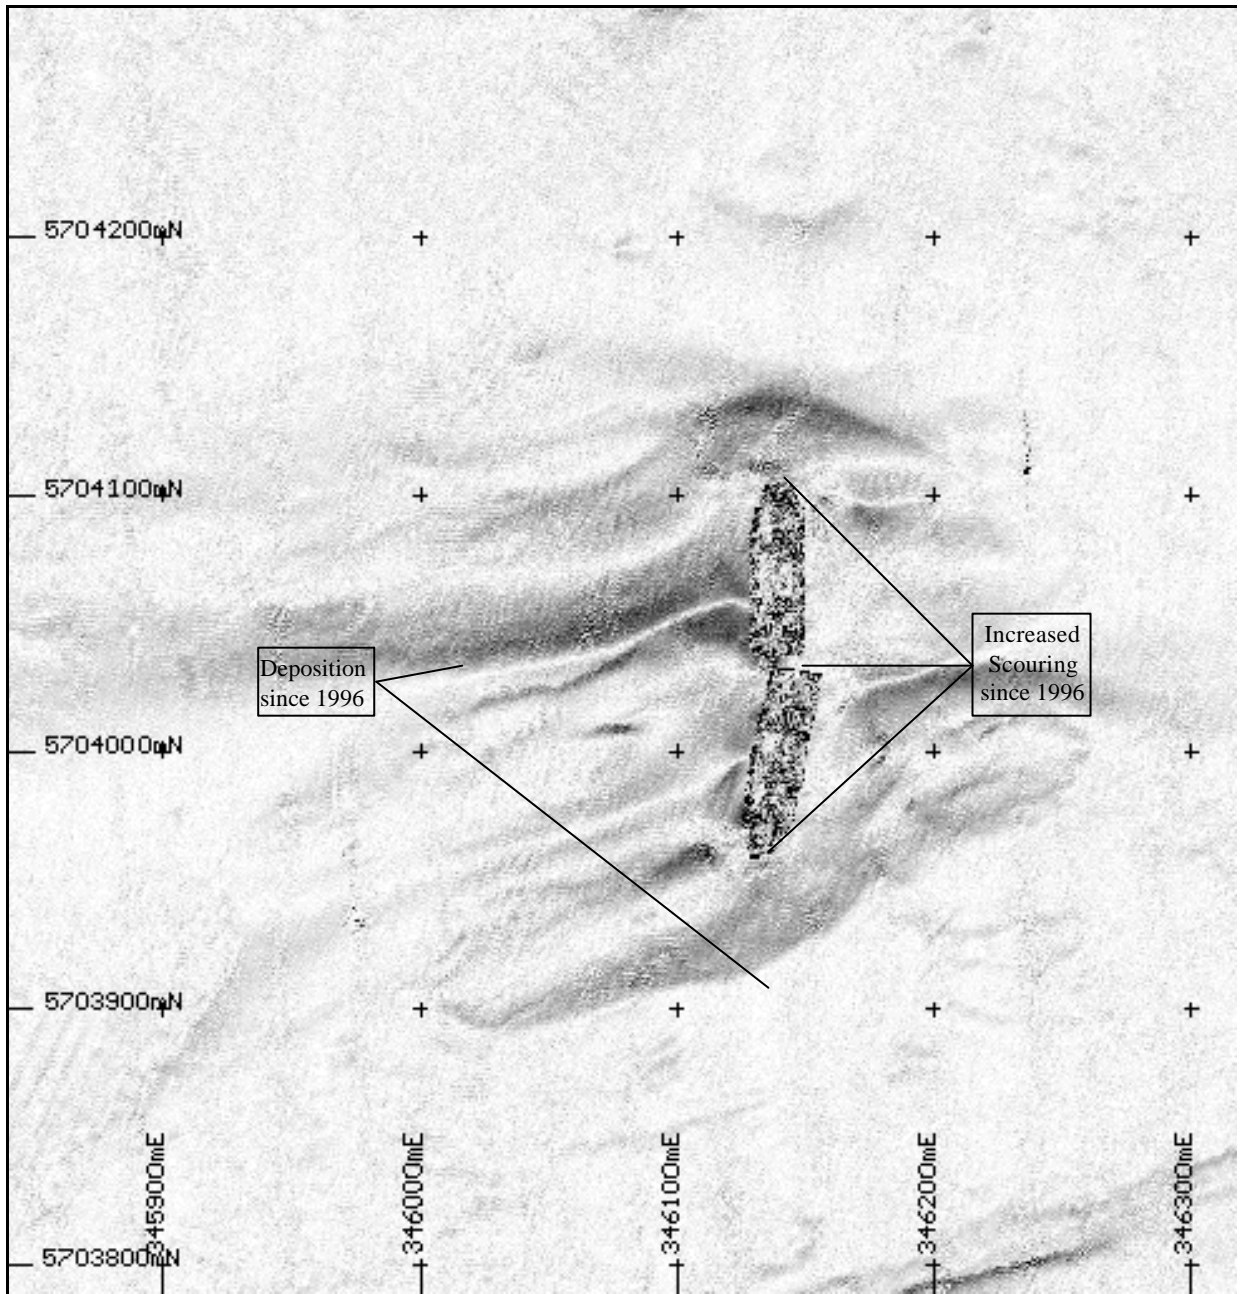
MONOCHROMATIC GRADIENT PLOT

A monochromatic gradient plot at Annex C reveals details of the ship's structure. This plot also reveals details of small seabed topographical features such as sand ripples over the area.
